Lincoln Creek on-site improvements *Findings* at 538 Lincoln St., Walla Walla, WA

WSI # 121-065-01
January 10, 2022

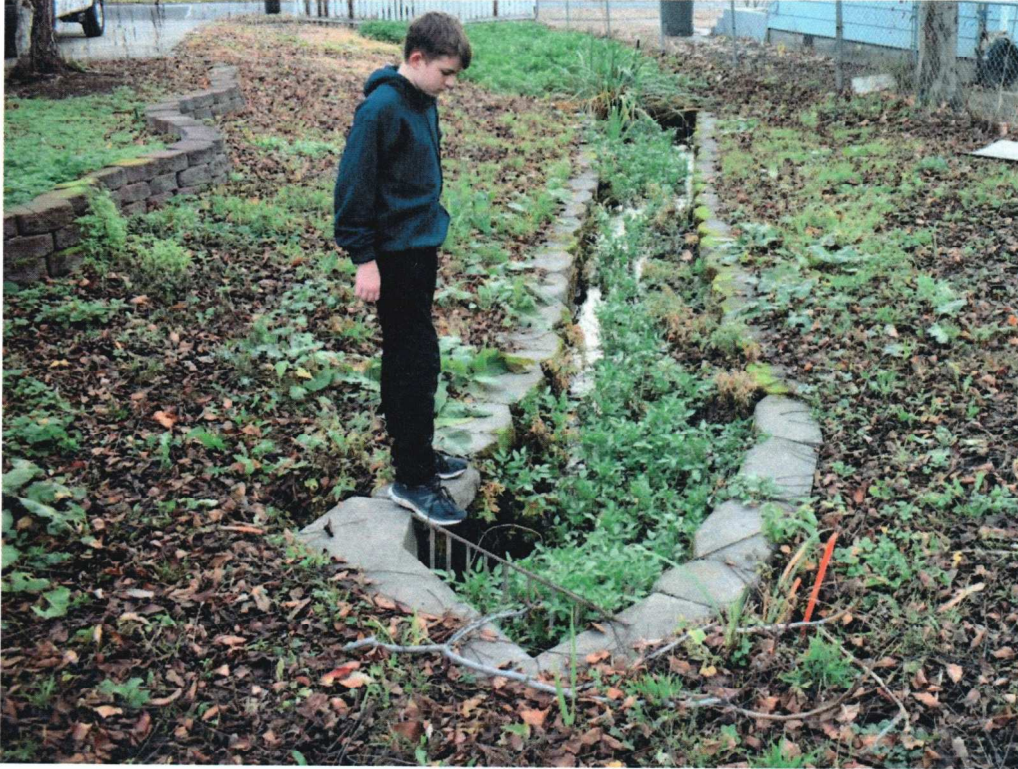
• Figure 1- current creek alignment before entering culvert

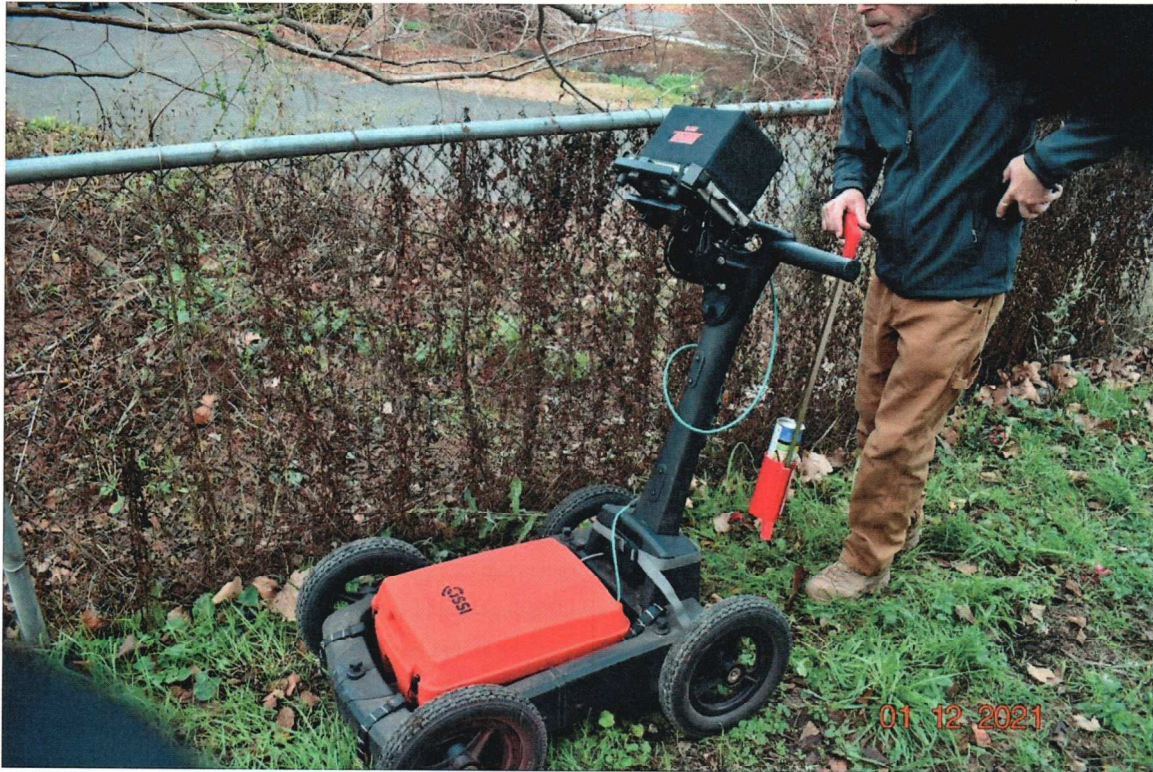
• Figure 1-locating turn for culvert with GPR

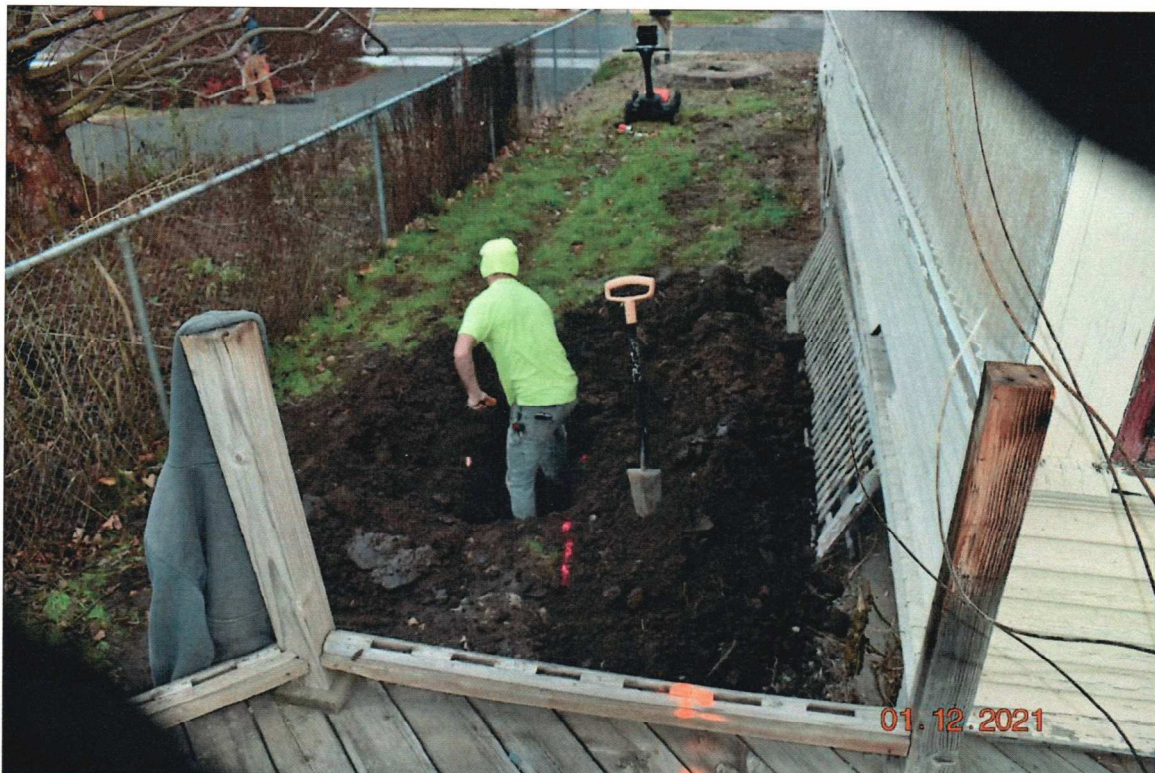
• Figure 2-excavating to locate Orangeburg pipe

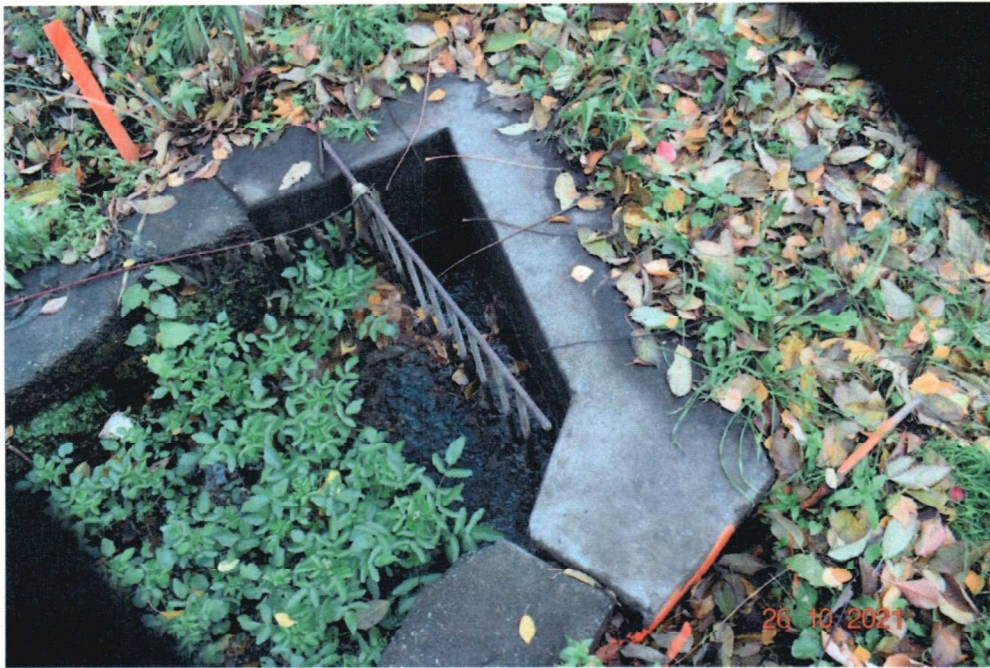
• Figure 3-culvert inlet

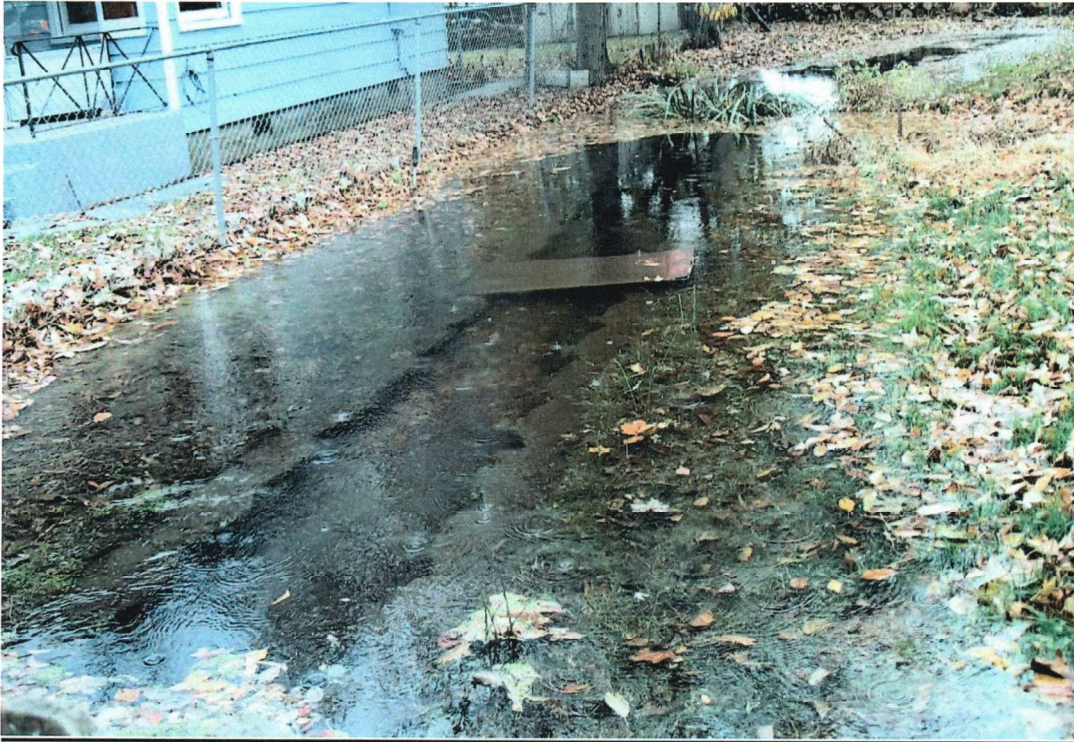
• Figure 4-flooding of creek on property during moderate rainstorm

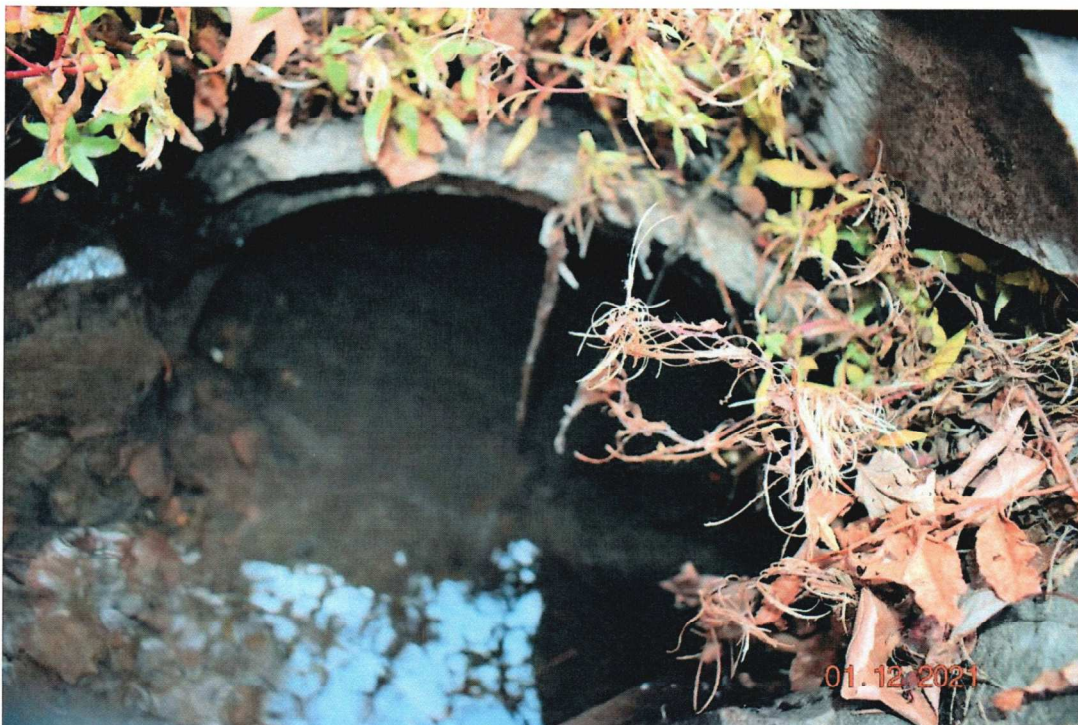
• Figure 5-culvert outlet on property to west. Note accumulated sediment

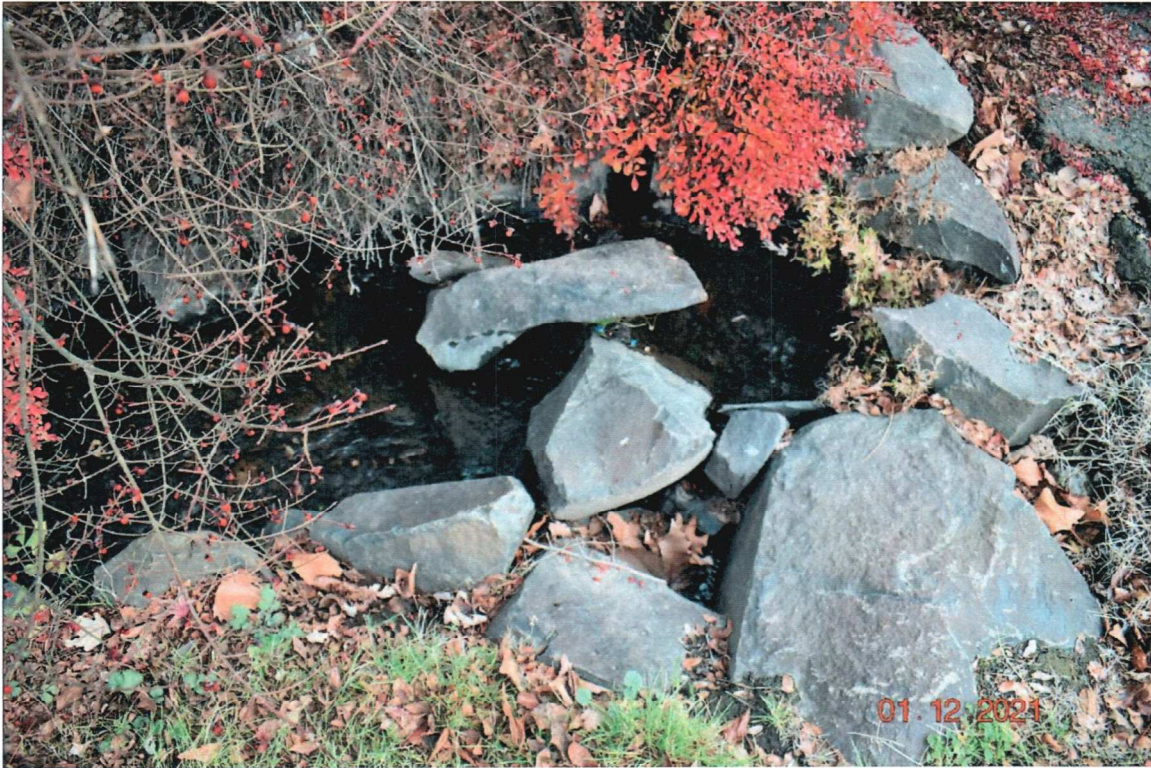
- Figure 6-Culvert outlet on adjoining property. Beyond the accumulated sediment, note the culvert is higher than the creek bed and cobble and boulders are installed to reduce erosion.

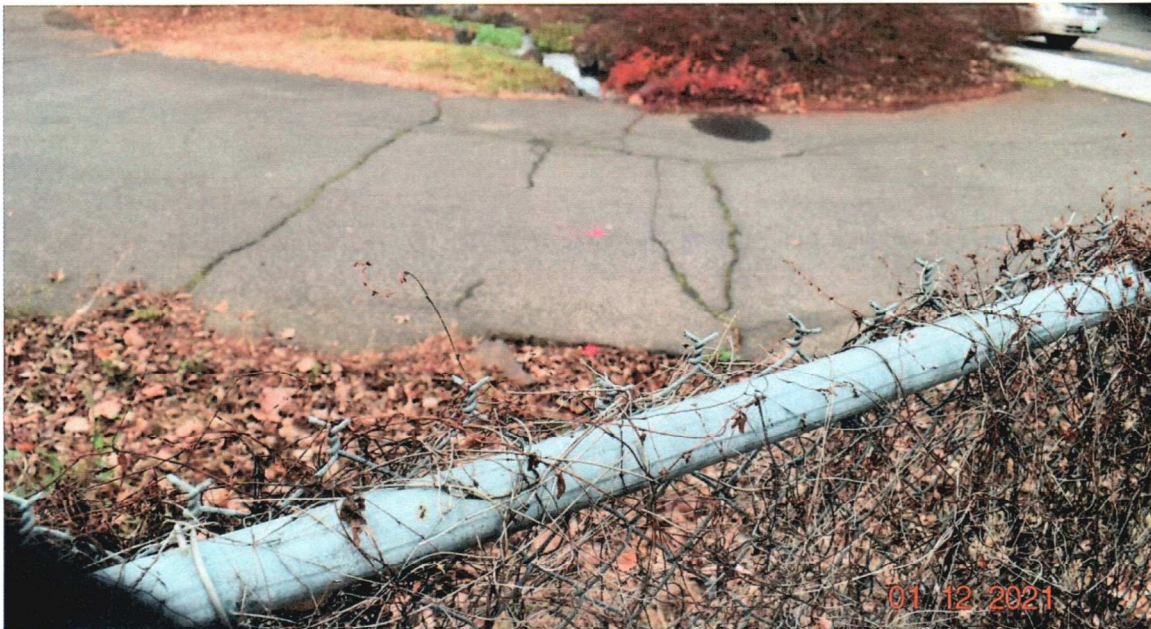
- Figure 7-culvert route from property to discharge on property to west

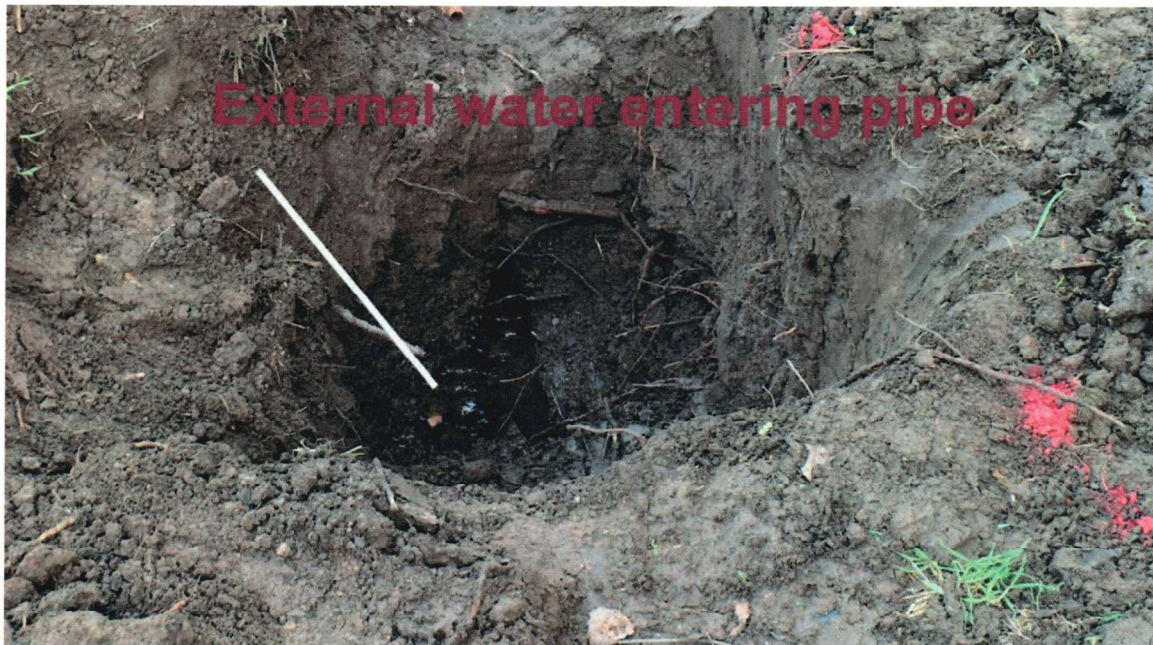
Given some error in the calculation of the cross-sectional areas, **it is inescapable that about 50% of the Lincoln Creek flow is not being transmitted by the pipe. It appears that good amount of the flow is transmitted around the pipe as evidenced by our excavation of the Orangeburg pipe.**

- Figure 8-the Orangeburg pipe is very near the top of the culvert. Significant water was running through the soil into the excavation.

The borehole to check groundwater level was still open and located within 10 ft. of the above excavation. Groundwater was still at over 7 ft. deep indicated most of the flow is within the area of the outside of the culvert and is not adding to the groundwater elevation.

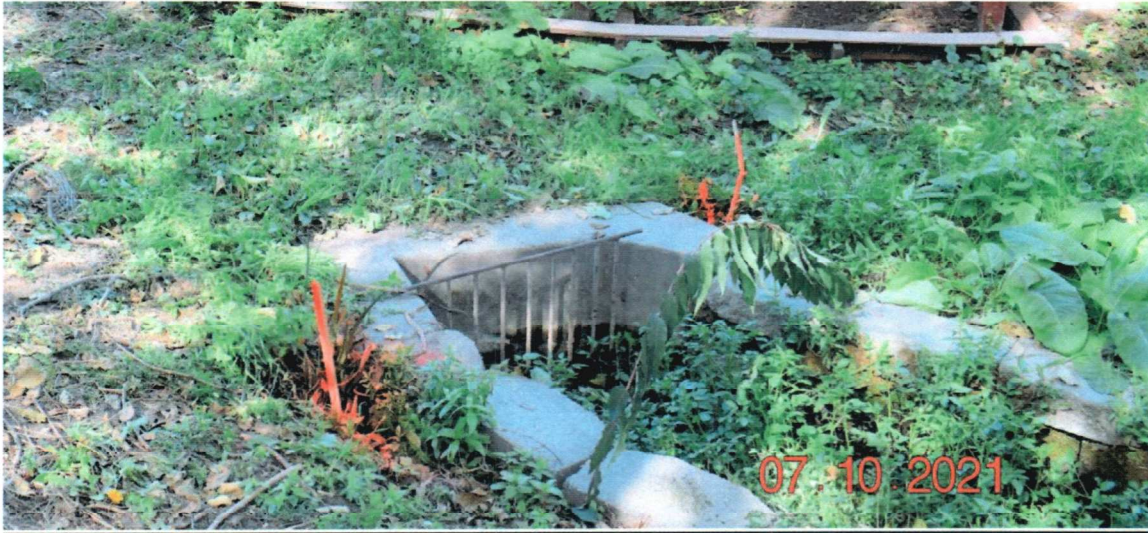
• Figure 9-Culvert inlet showing eroded sidewalls

Fig. 10 is instructive as significant erosion has occurred behind the block lining and around the periphery of the culvert. The orange paint and lathe were installed for warning for pedestrians to not step into the deep eroded holes. This is a strong indicator that significant creek flow is traveling on the outside of the culvert.

- a. **Lincoln Creek Conveyance-** The culvert will be abandoned and the entry sealed. A conveyance consisting entirely of surface flow via an open-channel conveyance will extend from the Howard Street culvert to the culvert on the adjoining property to the west. If the culvert on the property to the west cannot accept the flow, the surface conveyance on the property would overflow to the property to the west in the area of their culvert.

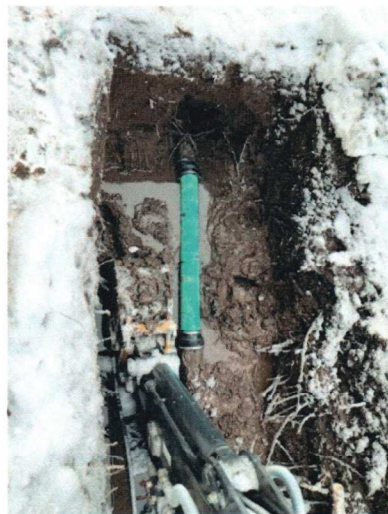
During the geotechnical investigation, the Orangeburg pipe was encountered and damaged. At that time, no effluent was discharging from the pipe as it was assumed to service the home and was not in alignment with the locate in the street.

• Figure 10-Orangeburg pipe run repair

This pipe was repaired with SDR 35 pipe with Fernco couplings during the week of December 27, 2001 by Clark Young Excavators. The photo below shows the repair.
